1997 Class A Diesel Freightliner

Est/Invoice# 64625

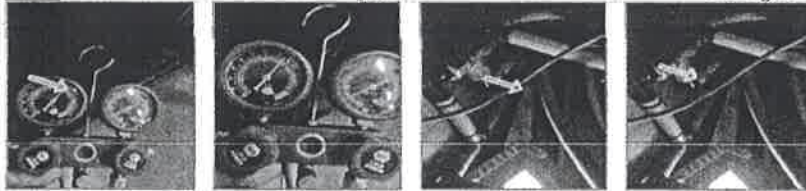
#	Insp Item	Notes
X	Tech Notes	Pressure held over night, next step would be to charge ac and install dye. Monitor. The poly bead line is not fully on the fitting. The poly bead is discontinued and has been replaced with pex line. Will need to move panel fully back and install a coupler to convert to pex line and then install a new fitting for a pex connection at valve. .

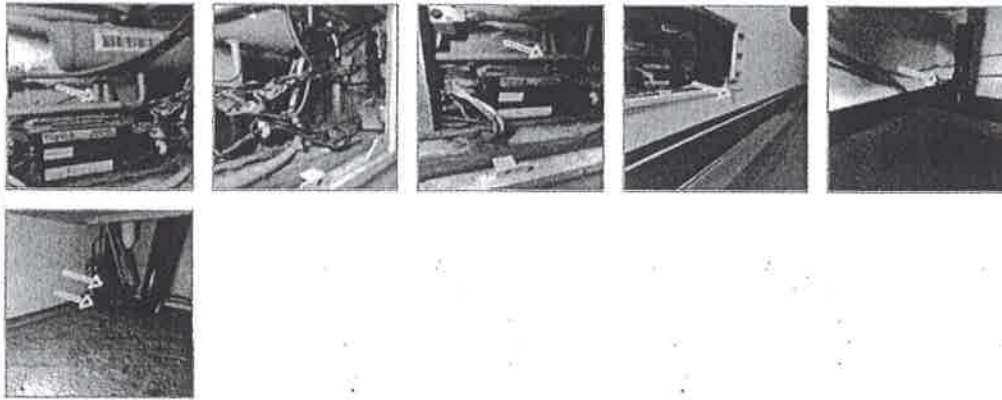
X	Tech Notes	Water flowing out from behind panel when trying fo fill tank

X	Tech Notes	Fridge coils covered in yellow residue. Water lines not hooked up to ice maker water valve. Has no water flow out of drinking tap and shutoff valve. for icemaker is seized and partly open. Has enough water flow that it's trickling out behind fridge at icemaker valve. There was napkins piled in corner by filter. Everything is dry at this point.
