**Sale Name:** September 26, 2025 - Friday Major Automotive & Recreational Live & Timed Auction

**LOT 133 - 2008 Ford F-150 4x4 XLT 4dr SuperCab Styleside 5.5 ft. SB**

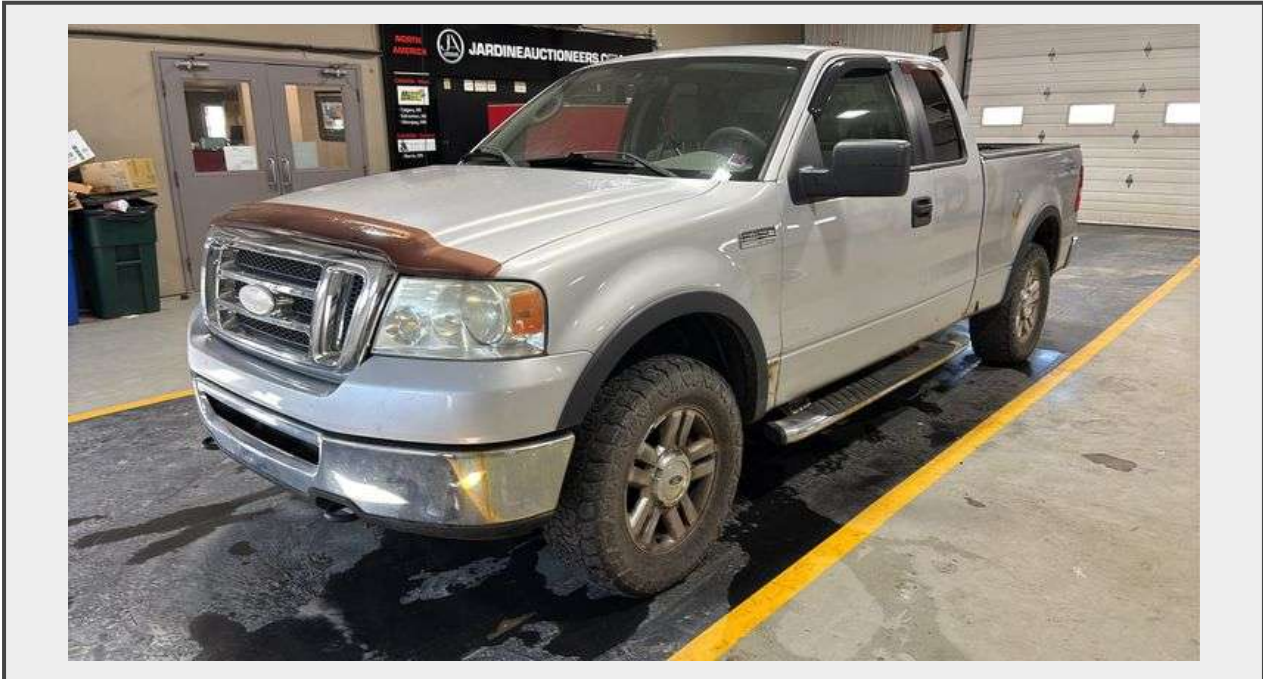
**Comments** Interior - Animal hair present throughout vehicle, headliner/seats/carpet stains, seats tears. Exterior - Multiple scratches/paint chips, front left fender paint peeling/rust, front left door paint bubbling/rust/inner door rust, rear left door paint bubbling/rust, rear left fender rust/holes/trim piece screwed into fender/repainted, rear bumper dents/rust, tail gate red, right rear fender paint peeling/rust, front right door paint bubbling/rust, front right fender paint peeling/rust, front bumper rust, windshield chips/chip cracks. \*Rear left fender holes, dip stick tube rusted on inside and unable to get dip stick back in/covered with duck tape. FEATURES - HITCH, TILT, CRUISE CONTROL, MANUAL SEATS, PWR MIRRORS, PWR LOCKS, PWR WINDOWS, HEAT FUNCTIONING, AC FUNCTIONING, HANDS FREE CALLING, CD PLAYER

Vehicle loud possible exhaust leak, rear left fender holes, dip stick tube rusted on inside and unable to get dip stick back in/covered with duck tape
